# Five-Year Review Report

Fourth Five-Year Review  
for  
Nyanza Chemical Waste Dump Superfund Site  
Ashland, Massachusetts

May 2009

The United States Environmental Protection Agency  
Region 1, New England  
Boston, Massachusetts

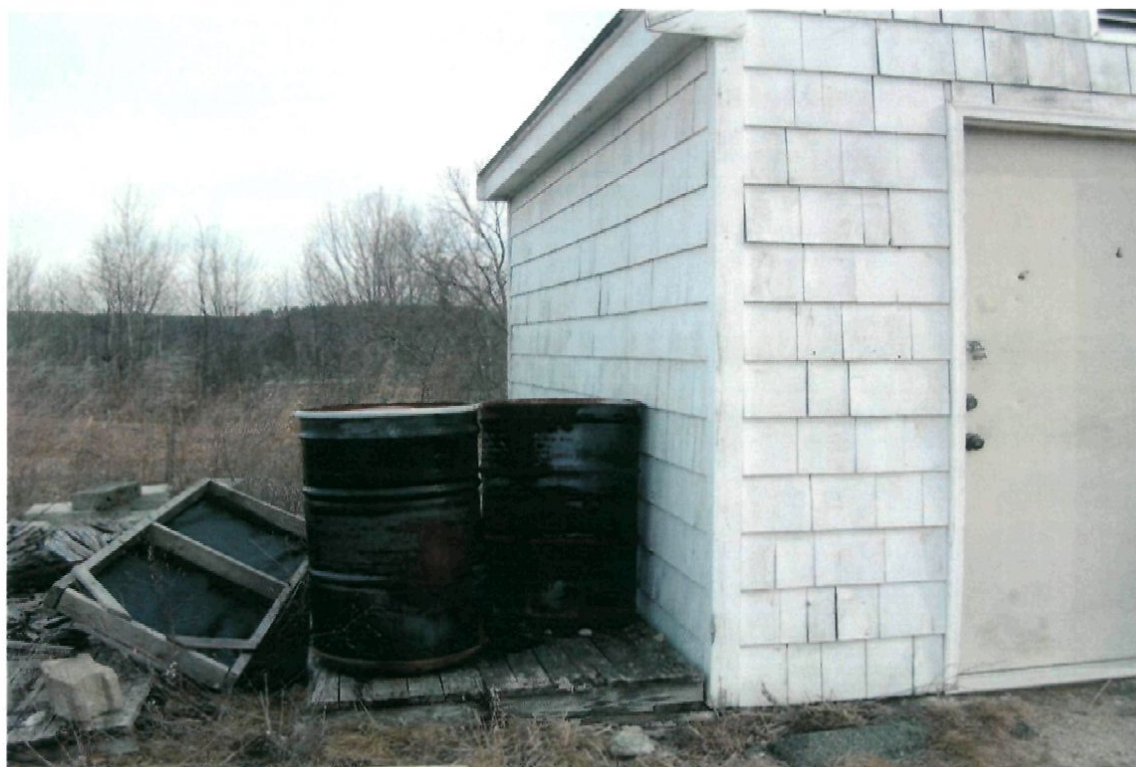
1. Two rusted and bulged drums were observed beside the storage shed.
2. Minor damage to the perimeter fence was noted near the South Gate.
3. A groundwater monitoring program for OU #2 as mandated by the Explanation of Significant Differences has not yet been implemented.
4. Eight of the vapor mitigation systems installed as part of OU #2 failed performance testing in winter 2008/2009.
5. The DNAPL extraction portion of the remedy has yet to be implemented.
6. The institutional controls for OU #2 mandated by the Explanation of Significant Differences have not yet been implemented.

- **Storage Shed** – Evidence of vandalism was observed at the storage shed. The outer pane of glass on the sky light was broken by a brick. The door to the storage shed is dented but was closed. The roof of the storage shed was also observed to need repair. Two bulged and rusted drums were observed on a palette next to the storage shed. The drums appeared to contain waste personal protective equipment (PPE) from site operations.

Photo Number 1 – Drums beside the storage shed.

1. Remove and properly dispose of the drums being stored near the storage shed.
2. Repair the damaged fence near the South Gate.
3. Implement a groundwater monitoring program for OU #2.
4. Investigate the cause(s) of reduced negative pressure readings in several systems and make repairs as needed.
5. Implement the DNAPL remedy.
6. Put institutional controls (i.e. zoning ordinance) in place to reduce the potential for exposure to contaminated groundwater and vapors.

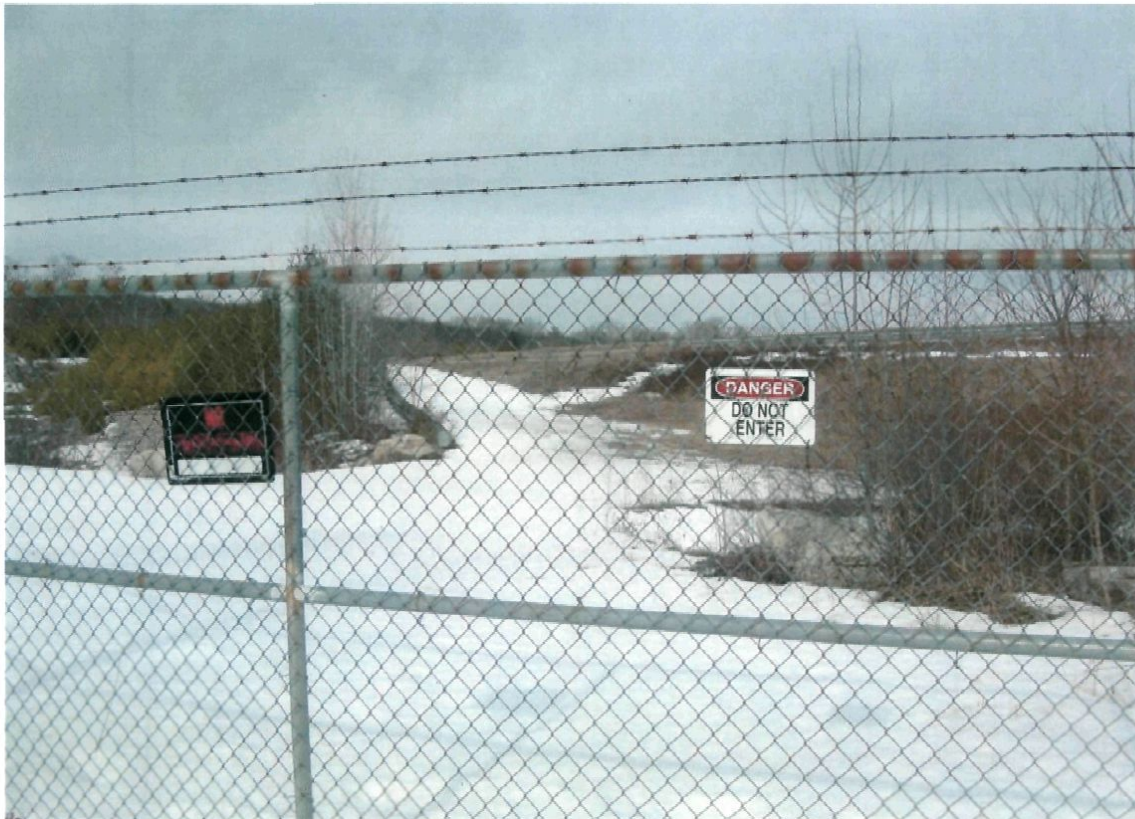
- **Site Fences and Signage** - The perimeter fence around the landfill cap was observed to be in good condition. Slight damage was observed to a small section of the fence near the South Gate; however the damage does not impact the overall integrity of the fence. Barbed wire was observed to be intact along the entire length of the perimeter fence. The four fence gates were observed to be locked and in good condition on the day of the Site inspection. No trespassing signs were posted at 20-foot intervals along the perimeter fence. All signs were observed to be in good condition.

Photo Number 4 – View of signs posted along the Perimeter Fence.

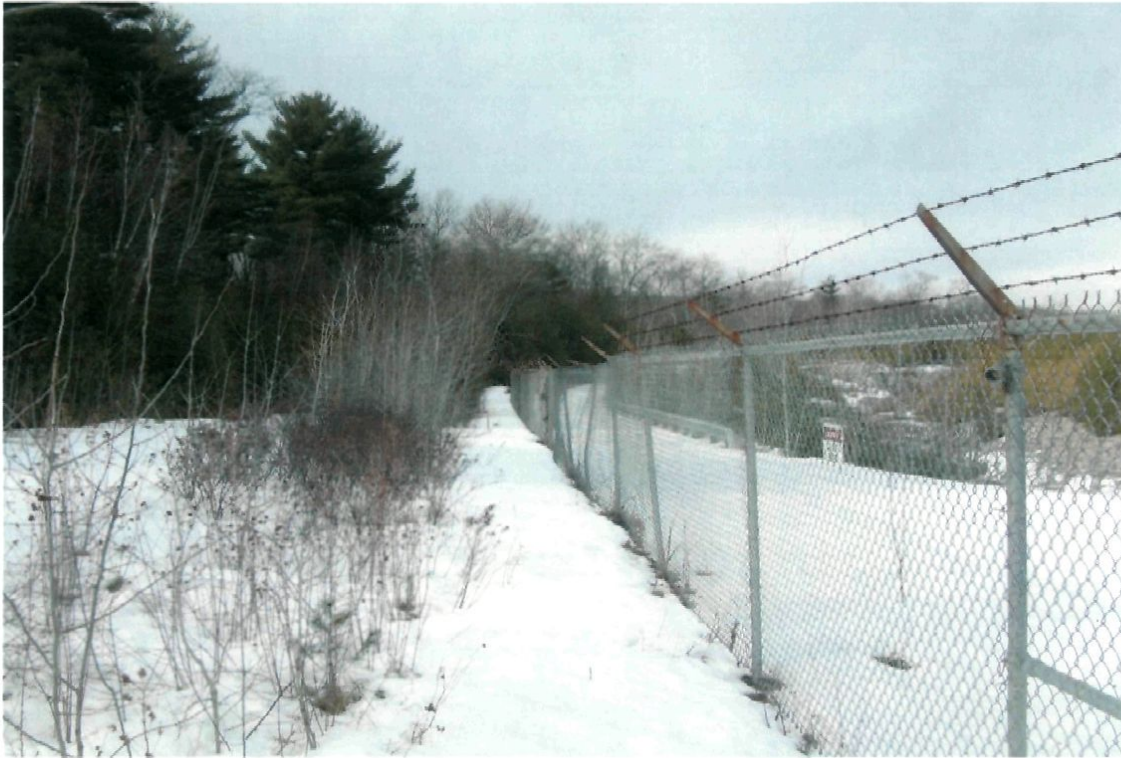
Photo Number 5 – View of minor fence damage near the South Gate.

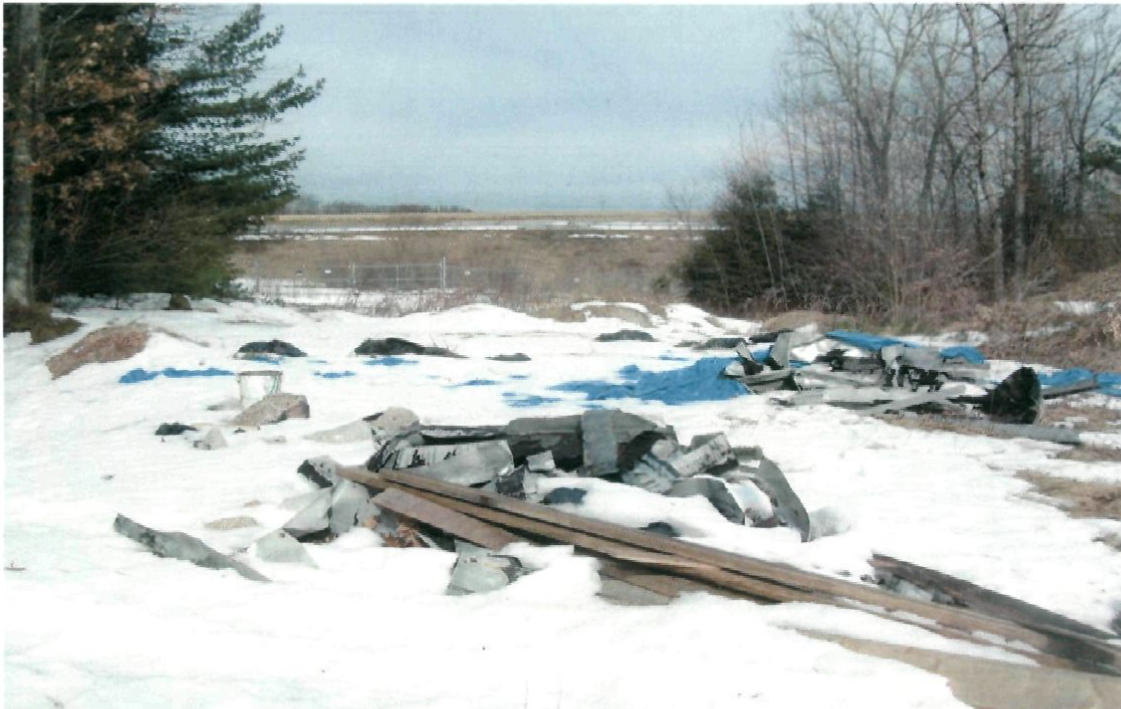
- **Roadways and Ditches** - The cap perimeter road appeared to be in good condition with no signs of erosion. The fence perimeter road and Trolley Brook road were snow covered on the day of the Site inspection. Evidence of trespassing was observed near Trolley Brook road and the South Gate. A pile of dumped debris including a tarp, shingles, and roofing materials was observed. The ditches and the Interceptor Trench appeared to be in good condition with well-maintained vegetation that had recently been cut back. No evidence of sedimentation was observed in the ditches.

Photo Number 6 – View of the trash/debris dumped near the South Gate.

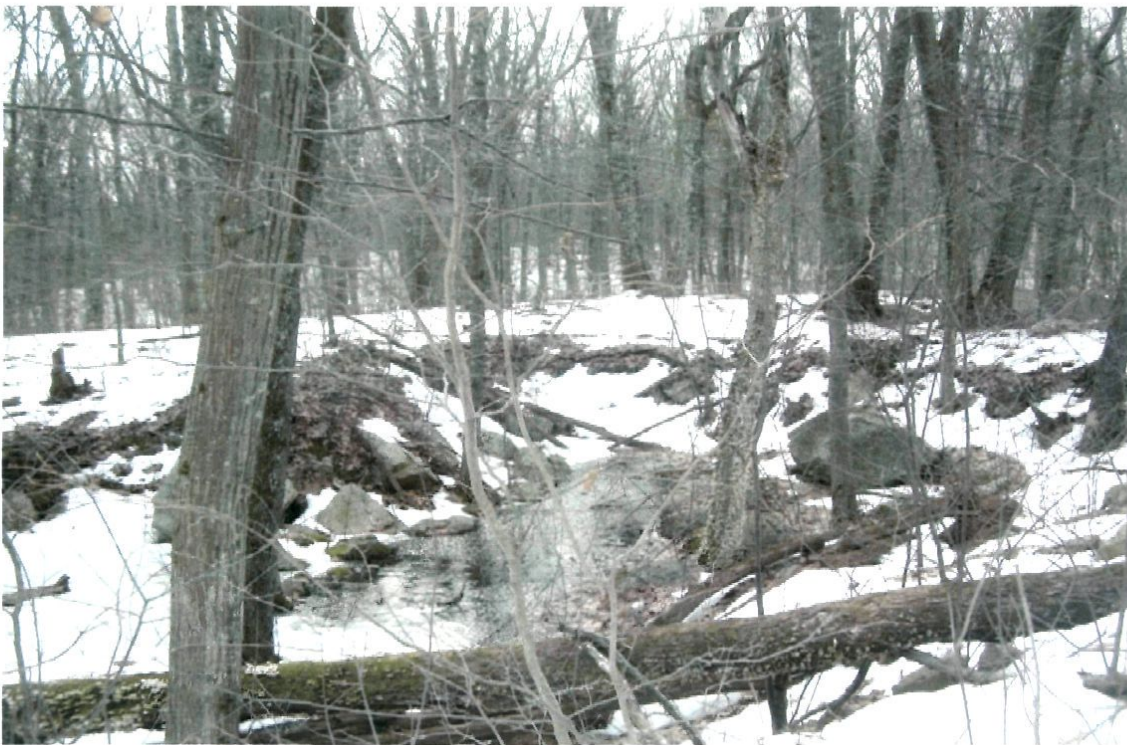
- **Eastern Wetland** – The Eastern Wetland was observed from Trolley Brook Road on the day of the Site inspection. The wetland area appeared to be in good condition.

Photo Number 8 – View of the Eastern Wetland from Trolley Brook Road.

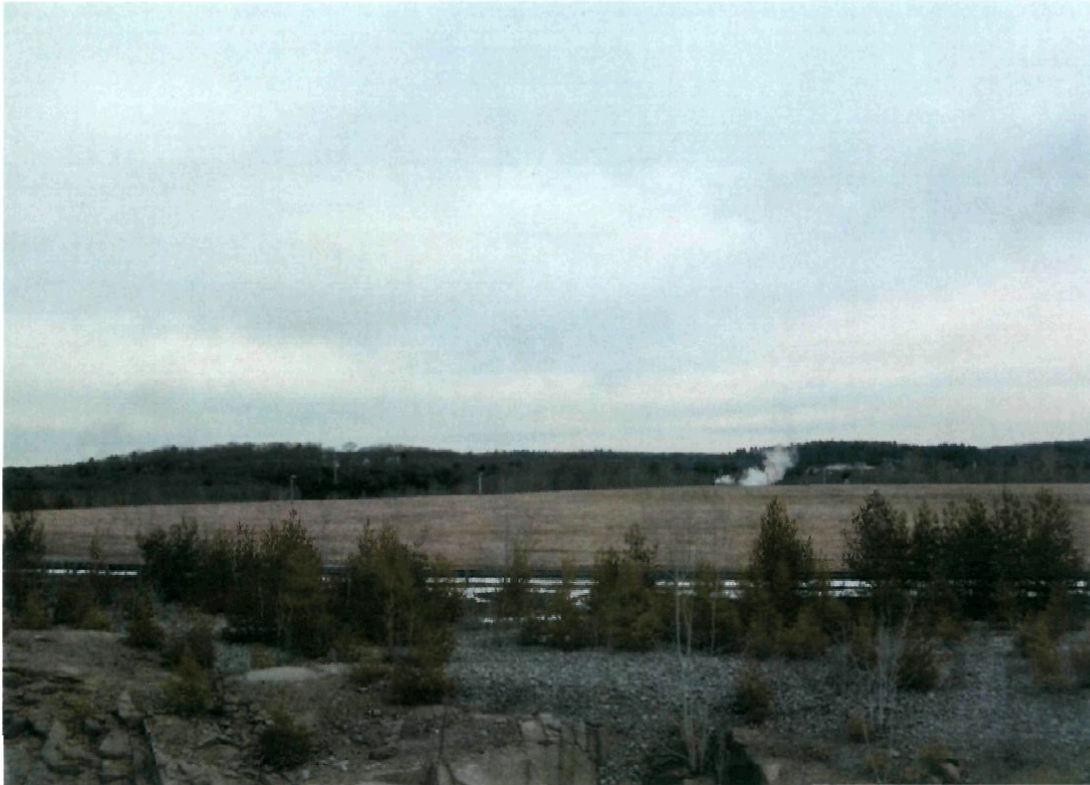
- **Landfill Surface** - The landfill surface was generally in good condition with healthy vegetation that appeared to be well maintained and no obvious signs of settlement, erosion, bulges, or cracks. Issues with vehicles driving on the landfill side slopes were noted during the 2004 Five-Year Review. The gravel on the side slopes was raked and vehicles entering the landfill site were advised to drive on the side of the cap where the slope is the least to prevent further damage. No evidence of damage to the landfill side slopes was observed during the 2009 Site inspection.

Photo Number 11 – View of the landfill cap and gas vents.

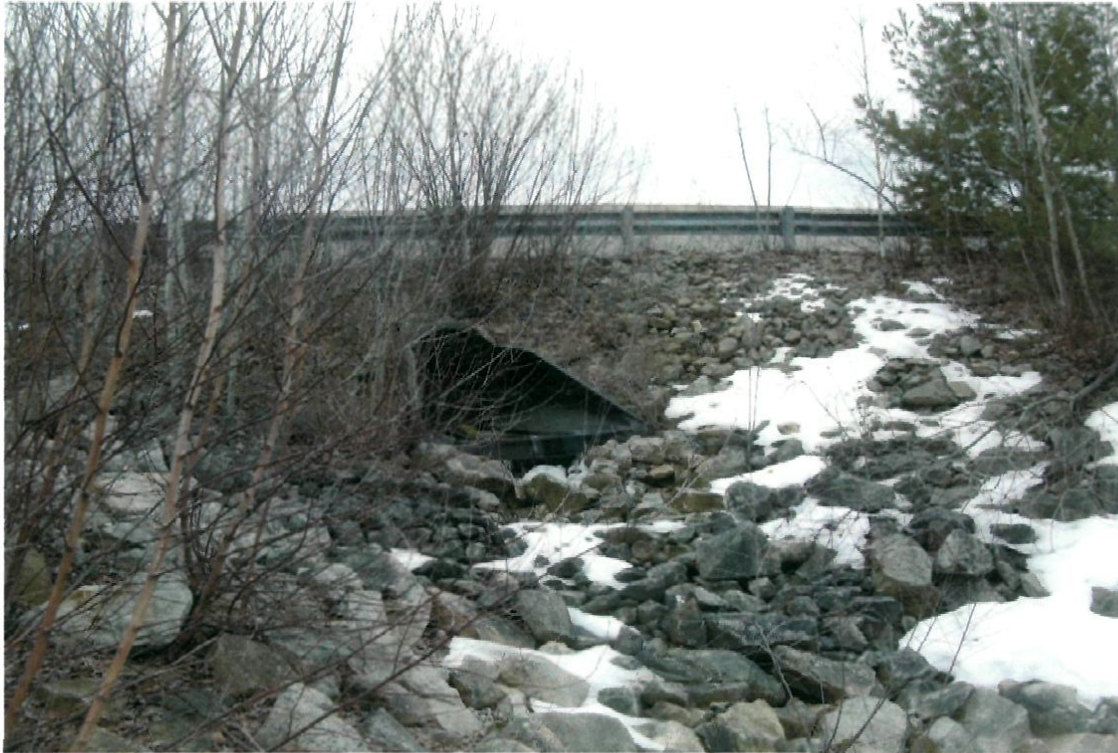
- **Perimeter Drain Outlet** - The perimeter drain outlet was observed to be in good condition. Water was flowing from the outlet on the day of the Site inspection.

Photo Number 13 – View of the Perimeter Drain Outlet.

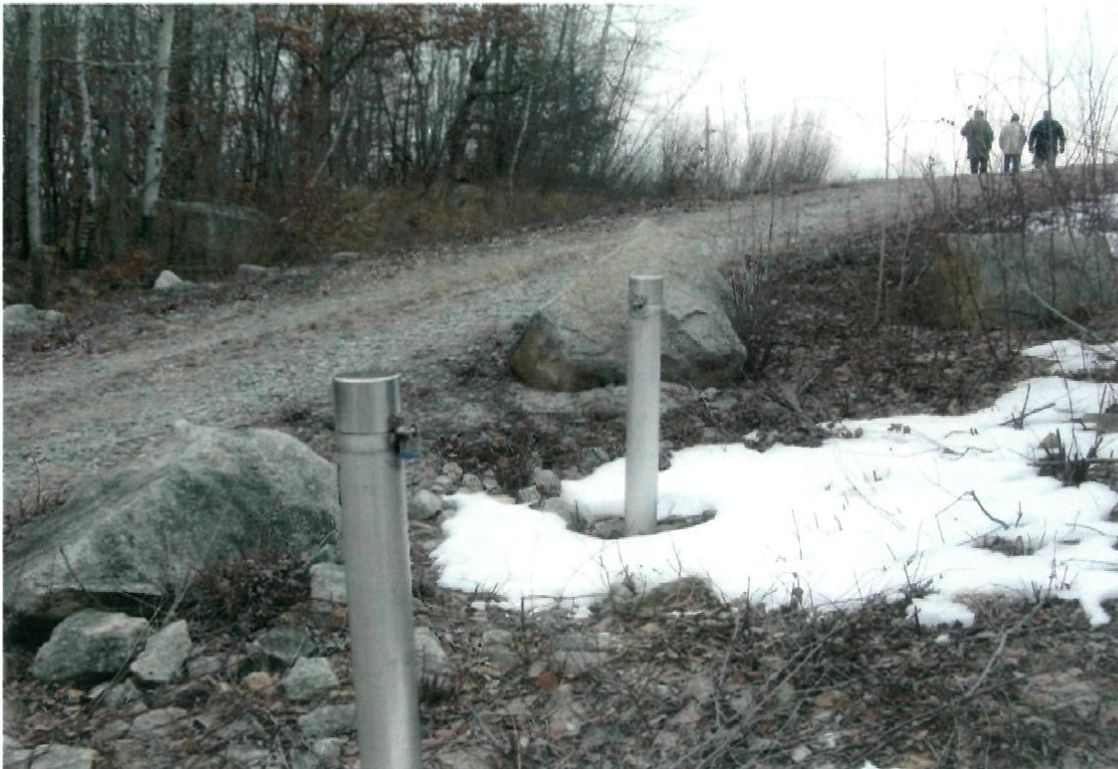
- **Monitoring Wells** – The monitoring wells located within the boundary of the perimeter fence were observed to be properly secured and in good condition.

Photo Number 14 – View of monitoring wells MW-505A and MW-505B.

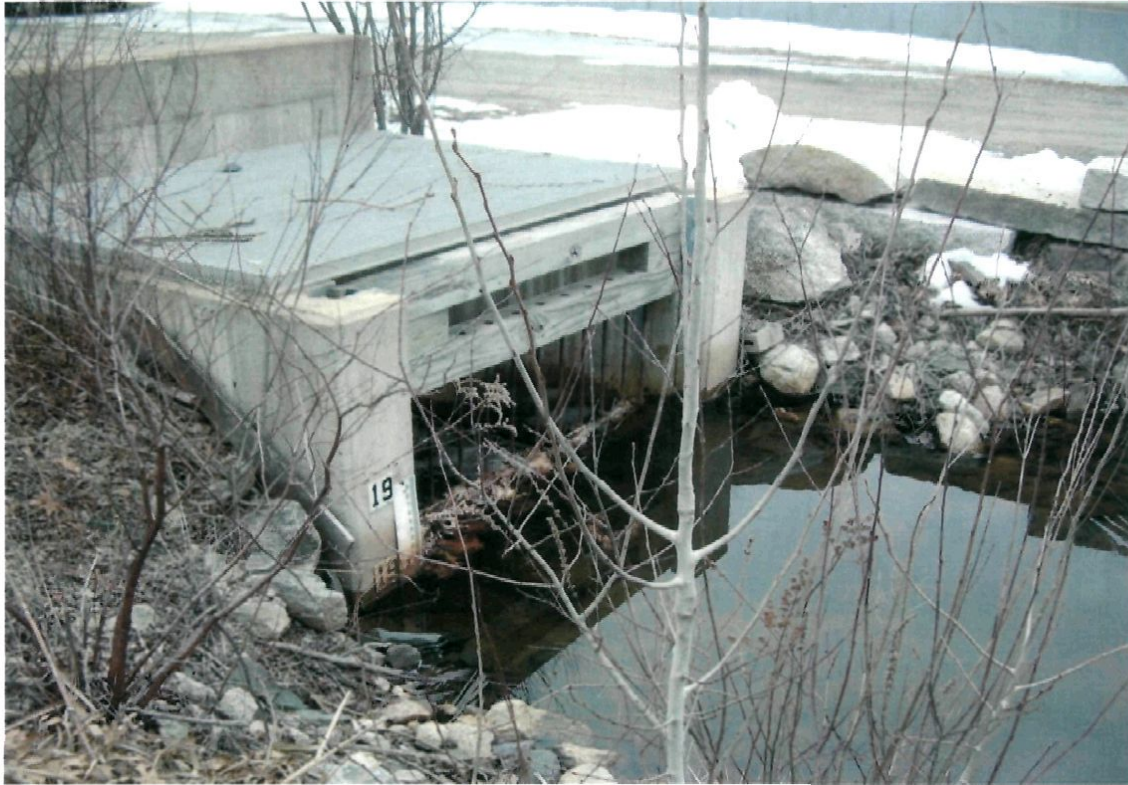
- **Control Weir** – The structure appeared to be good condition. Minimal debris was observed at the weir gate on the water surface which consisted of leaves and small branches. The water level measurement on the weir was noted at 2.8.

Photo Number 15 – View of the Control Weir.

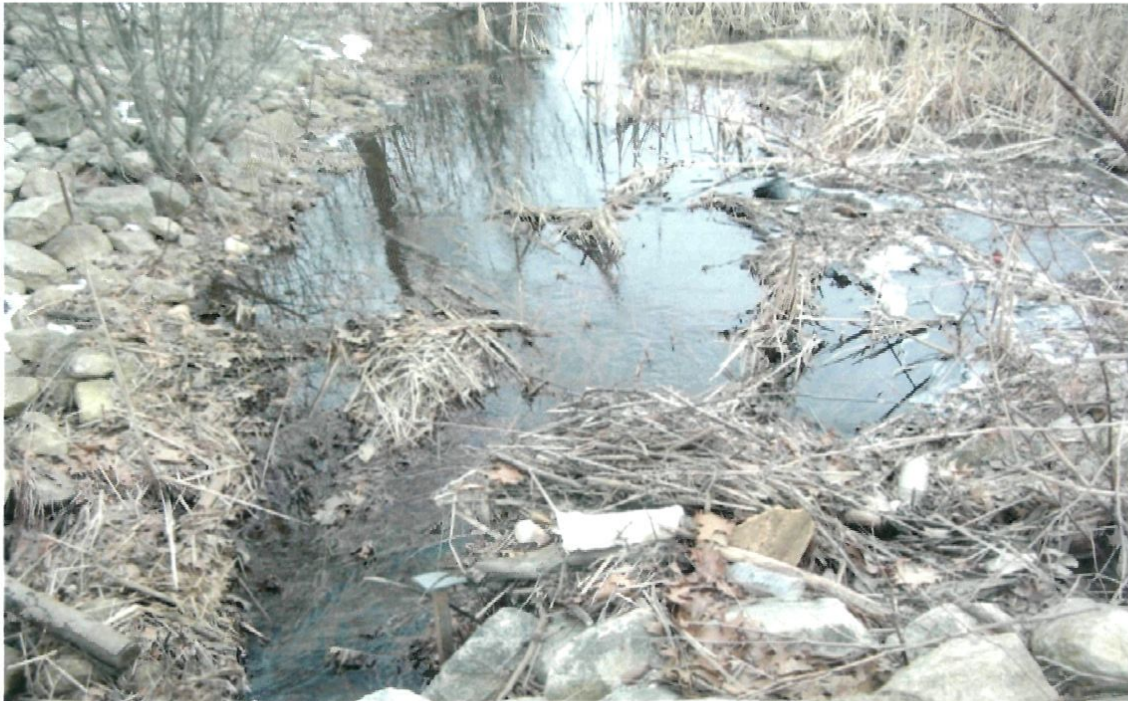
- **Trolley Brook and Chemical Brook** – A build up of debris was observed at the confluence of Trolley Brook and Chemical Brook. It is likely that the debris was restricting the flow into the Chemical Brook culvert.

Photo Number 16 – View of debris buildup at Trolley and Chemical Brooks.

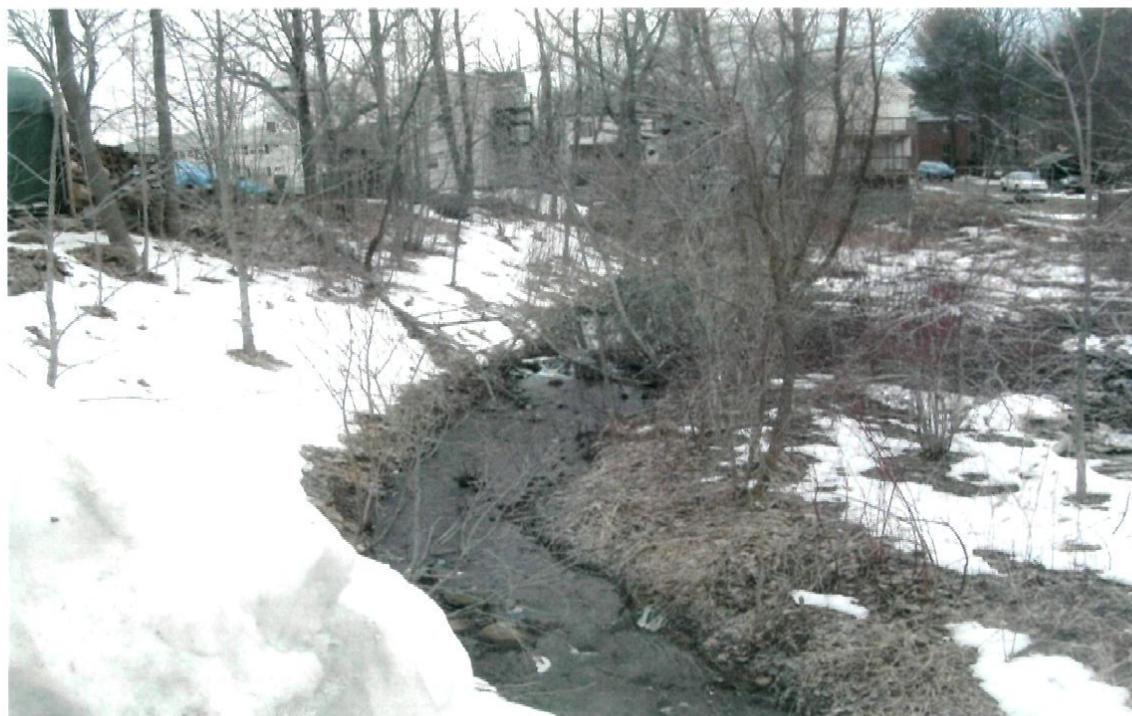
- **Lower Raceway** – Iron fouling/staining was observed along portions of the Lower Raceway. The cause of this was not apparent on the day of the Site inspection. The remainder of the area appeared to be in good condition, and no additional concerns were noted.

Photo Number 18 – View of the Lower Raceway Area.
